Ditch 3 Upper Line Replacement March 2020

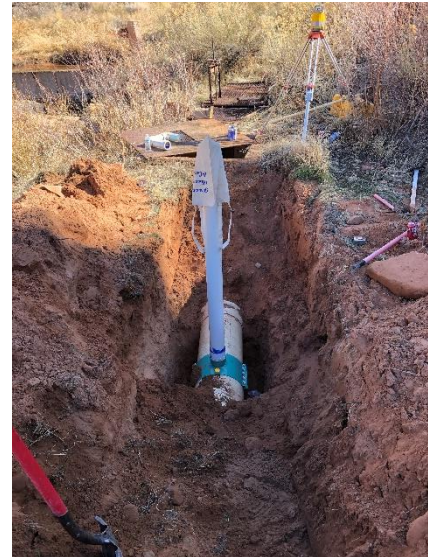
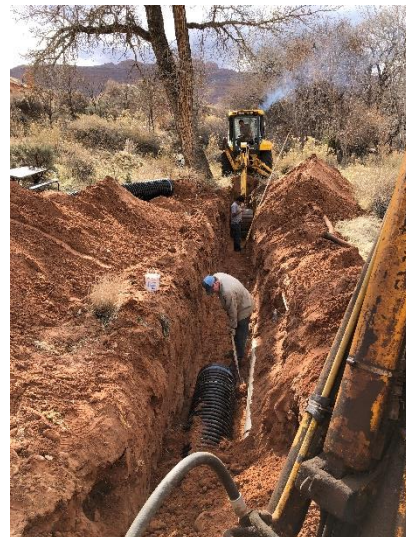
Next we had to installed the culvert section. The land owner had purchased 200' of 18" culvert so that we could sleeve our line. By doing this, it made for more real estate available to him on top for

his properly. In the future if the line for some reason sprung a serious leak in this area, it could be pulled out of the sleeve, repaired, and reinserted.

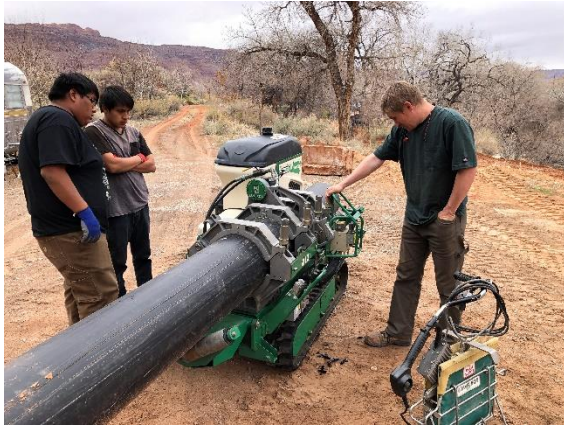
The culvert installation took several days. This area use to be the site of the old Moab Powerplant. The powerplant use to take water from Mill Creek to generate electricity for the town. Remnants of this powerplant can still be found. We tried to install this 200' of culvert in a fairly straight line, but in maintaining grade we dug into a massive cement box buried in the ground that blocked our path. This

meant we had to back up and reroute the culvert. We could not put sharp bends in the culvert as it would restrict the insertion of the HDPE pipe. It also meant we would now have to cut through the small water lines that Tom Johnson had installed in the area.

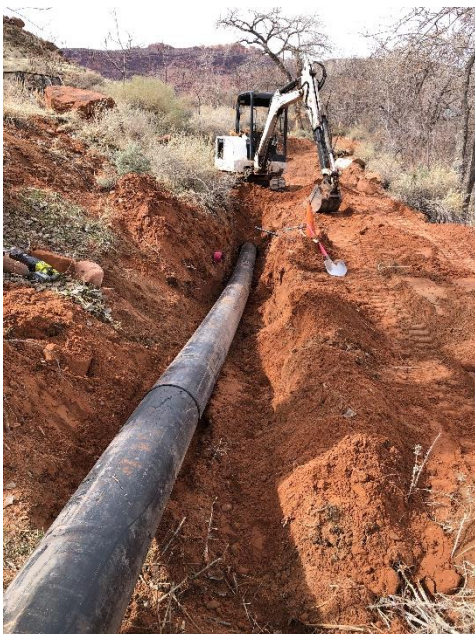
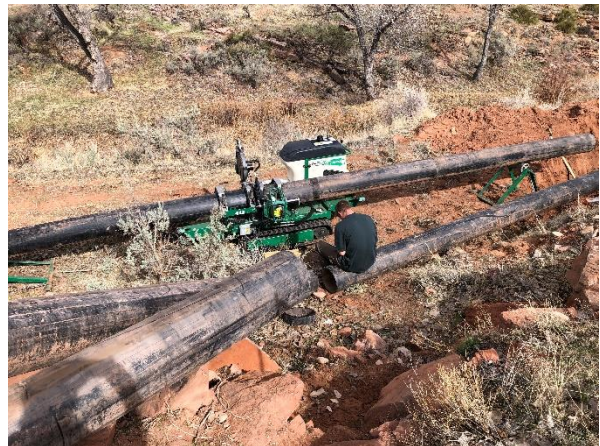
The machine was set up on a wide spot on the bench

just before the culvert starts. This HDPE pipe has a little flex to it, and even more so when it

was warm. We found it was a lot easier to deal with the pipe in the afternoons after it had warmed up. A rounded cap was welded onto the first piece of pipe so that it would slide through the culvert easier. The backhoe and mini-ex was used to pull the line into the culvert as it was constructed. The process went well. The only issue was that it took 45 minutes for each weld to be completed. First you clamp down the two ends of the pipe in the machine. Then a cutter shaves off the end of each pipe end so that you have perfectly clean and

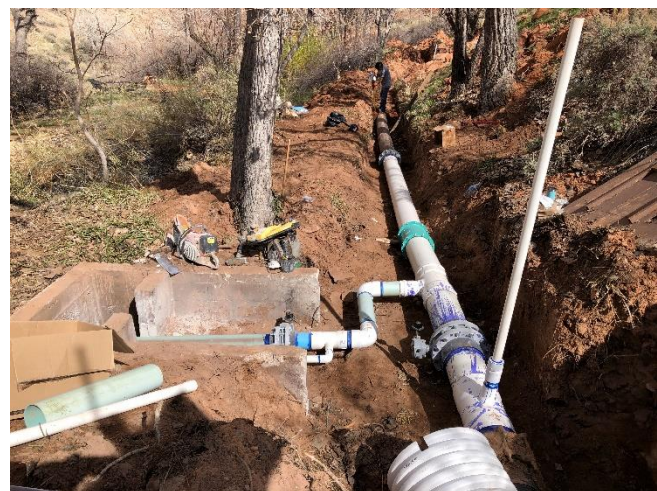
This was pretty straight forward construction. Mechanical couplers had to also be installed on each end of the HDPE to allow proper mating of the flanges. We kept the lower cement box portion that led to Walker's pipeline. Part of that had been a sand trap and it was mostly full

of dirt. The Walker line also got a small “raccoon” water line, because that is how Janie uses water for the most part. She just needed a small line for that.
