## Lower Diversion Dam Repair

In 2008 a major project was undertaken by the company to repair the lower diversion dam. When the dam was originally built, rock gabions were used as the primary building block of the dam. The gabions were then capped with a layer of cement. These gabions were slowly coming apart over time. A point was being reached where the whole dam was in danger of collapsing.

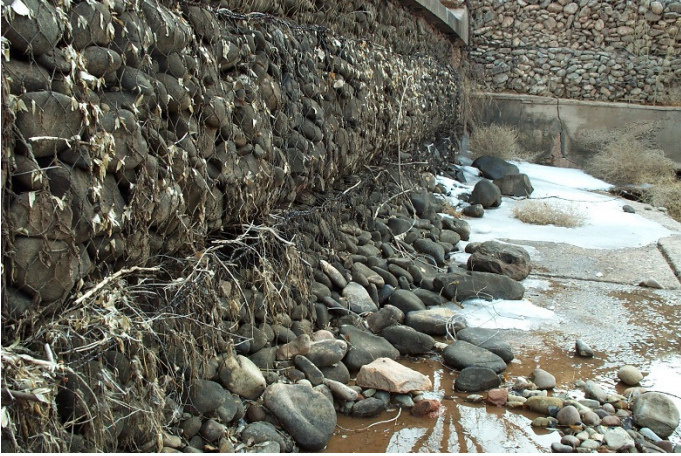
In this picture you can see how the gabions were shedding rocks. The wires holding the gabions together were breaking in my locations.

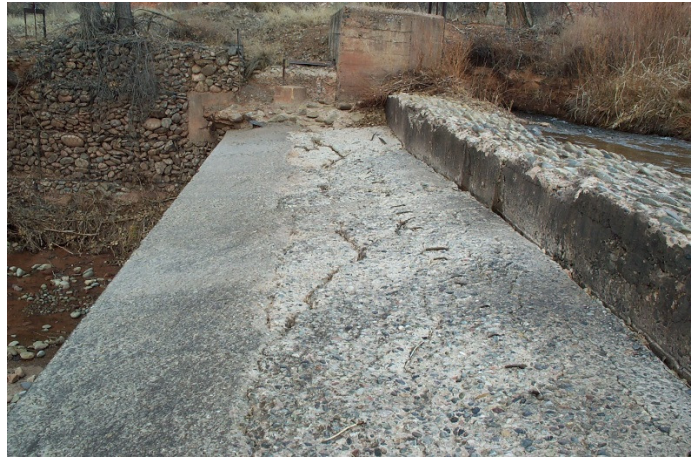
The cement cap on the top of gabions was showing significant cracking and we were afraid large chunks would be breaking off in the near future.

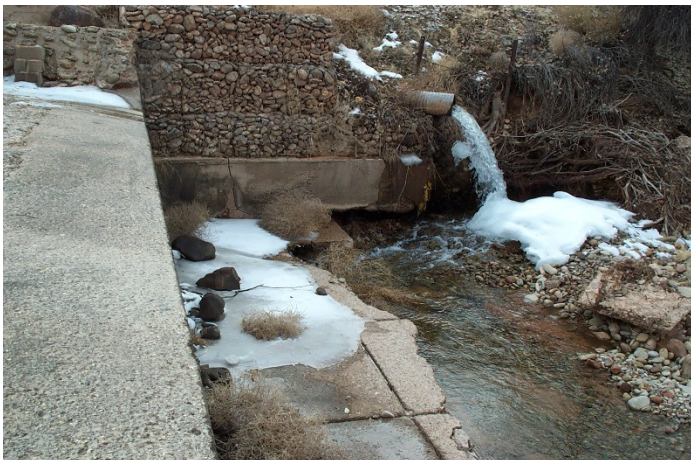
The lower apron had been breaking away for years and was only half the size as it had been originally created.
