Root Plugs

The pipe line on Ditch 3 between the diversion dam and the splitter box seems to be extra prone to this issue. Several years ago, the water flow had become less and less.

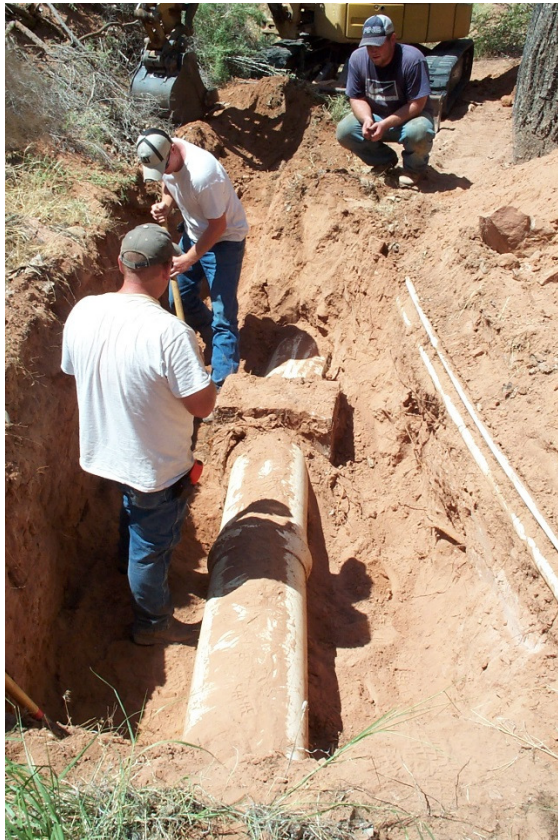
We asked the city to help us by running their pipeline camera down the line and at 300 feet below the Diversion Dam we ran into a blockage.

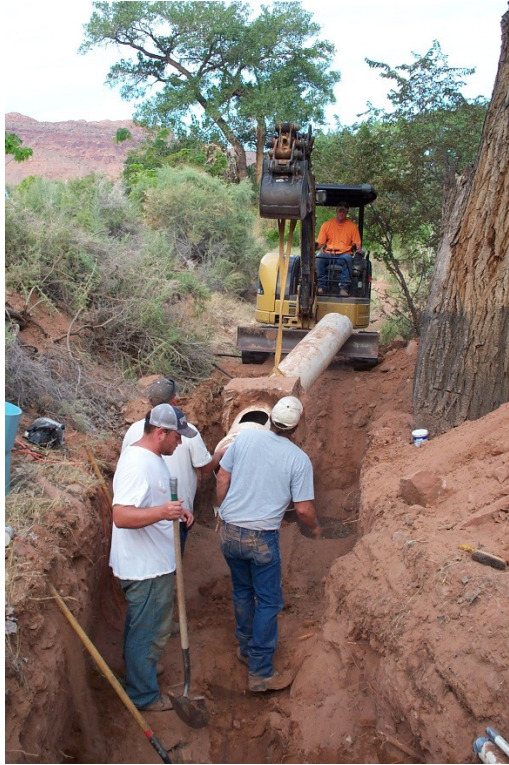
Digging into the line, we soon discovered a cement block that we did not know existed. Apparently, sometime in the past, there had been a leak at this point in the line. Most likely due to trying to bend the line around a tree. To stop the leak, duct tape and cement was used to stop the leak. That kind of repair does not hold and with a tree right there looking for water, roots soon entered the line and began to expand.

The old cement and portions of the pipe were removed.

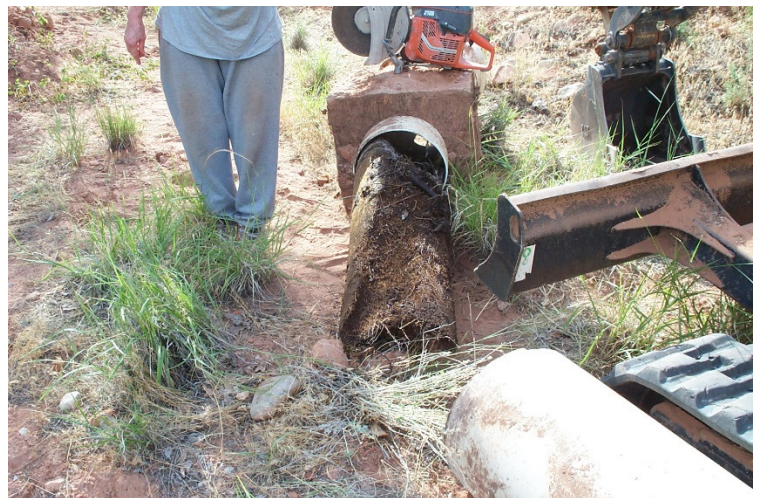
A five foot long root plug was found inside the old pipe.

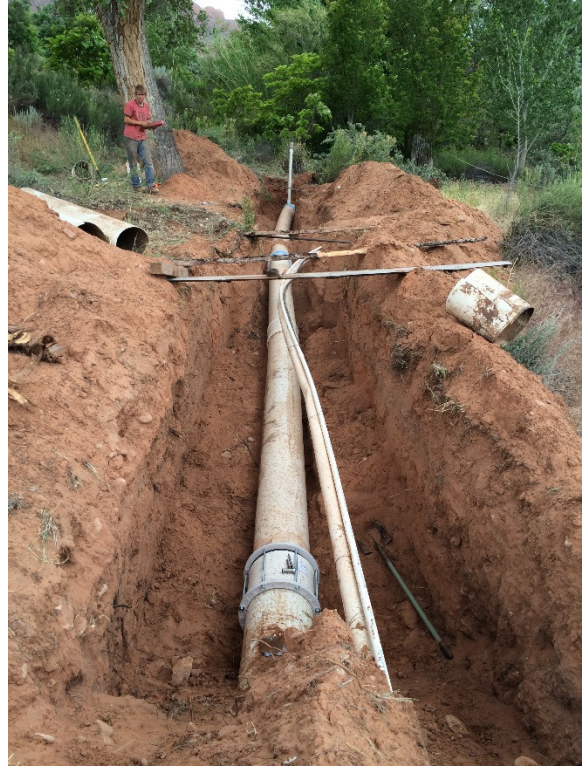
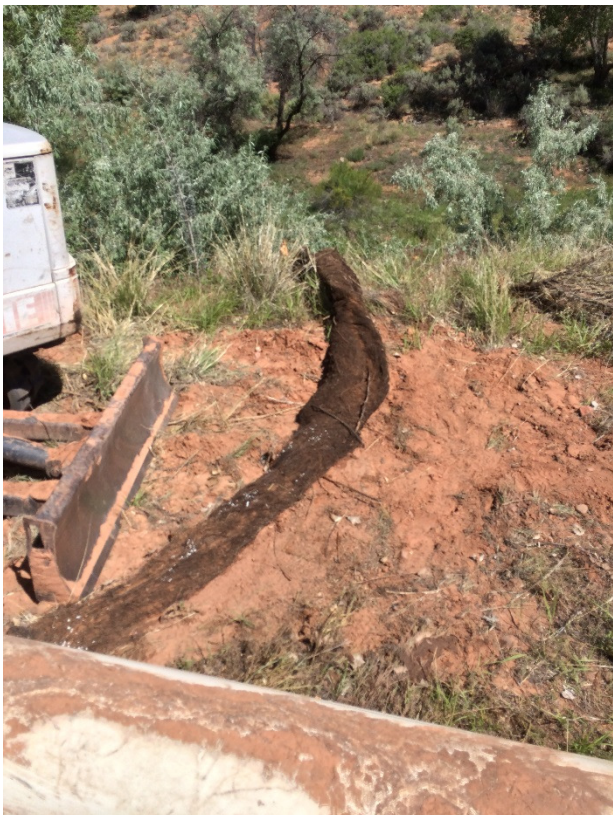
A root plug that had to be at least 15' long was found inside the 15" diameter pipe. This was a large root plug. The water flow was much improved after its removal.
