Ditch 3 Upper Line Replacement March 2020

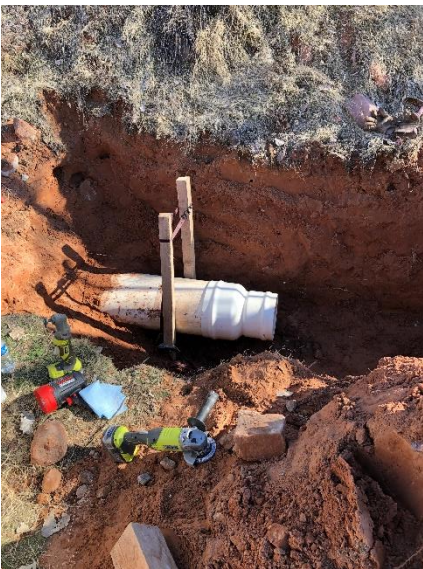
The irrigation line between the dam and the splitter box had become restricted. Years ago when it was constructed the gaskets were installed backwards in this portion of the line. This caused them to become partially dislodged when the pipes were inserted together. This resulted in small leaks at the joints. Vegetation found these leaks and sent roots into the inside of the pipe which has caused blockages inside the pipe. Several large root blockages were removed in previous years, but sections of the line still had issues resulting in a restricted water flow. In 2019 the long period of high water from spring runoff resulted in a lot of sand entering the system which collected at these root blockages. What water flow we were getting (which wasn't a lot) was cut in half.

One of the first things we did was to install an air vent at the top of the line. The line always had trouble with air in the line because it wouldn't vent properly. An inspection showed that the first 125' of the 15" line was still in good shape but after that it had problems. The line had not been bedded in properly years ago and the pipe itself was "flat" on the top from the dirt pressing down. It's surprising that the plastic pipe had not just split in half. We had to back up to a fitting that was a stronger point, but as it was, we still had to deal with an egg shaped end that had to be squeezed together to get it round enough to press on the gasket reducer.

This year the opportunity presented itself to replace this portion of the line. High quality HDPE pipe was obtained from the Hoodoo Motel construction. Also one of the land owners was wanted to sleeve the pipe on his property. We were also having a problem with a rock area that was threatening to seriously damage the plastic line.
