## Lower Diversion Dam Repair

In 2008 a major project was undertaken by the company to repair the lower diversion dam. When the dam was originally built, rock gabions were used as the primary building block of the dam. The gabions were then capped with a layer of cement. These gabions were slowly coming apart over time. A point was being reached where the whole dam was in danger of collapsing.

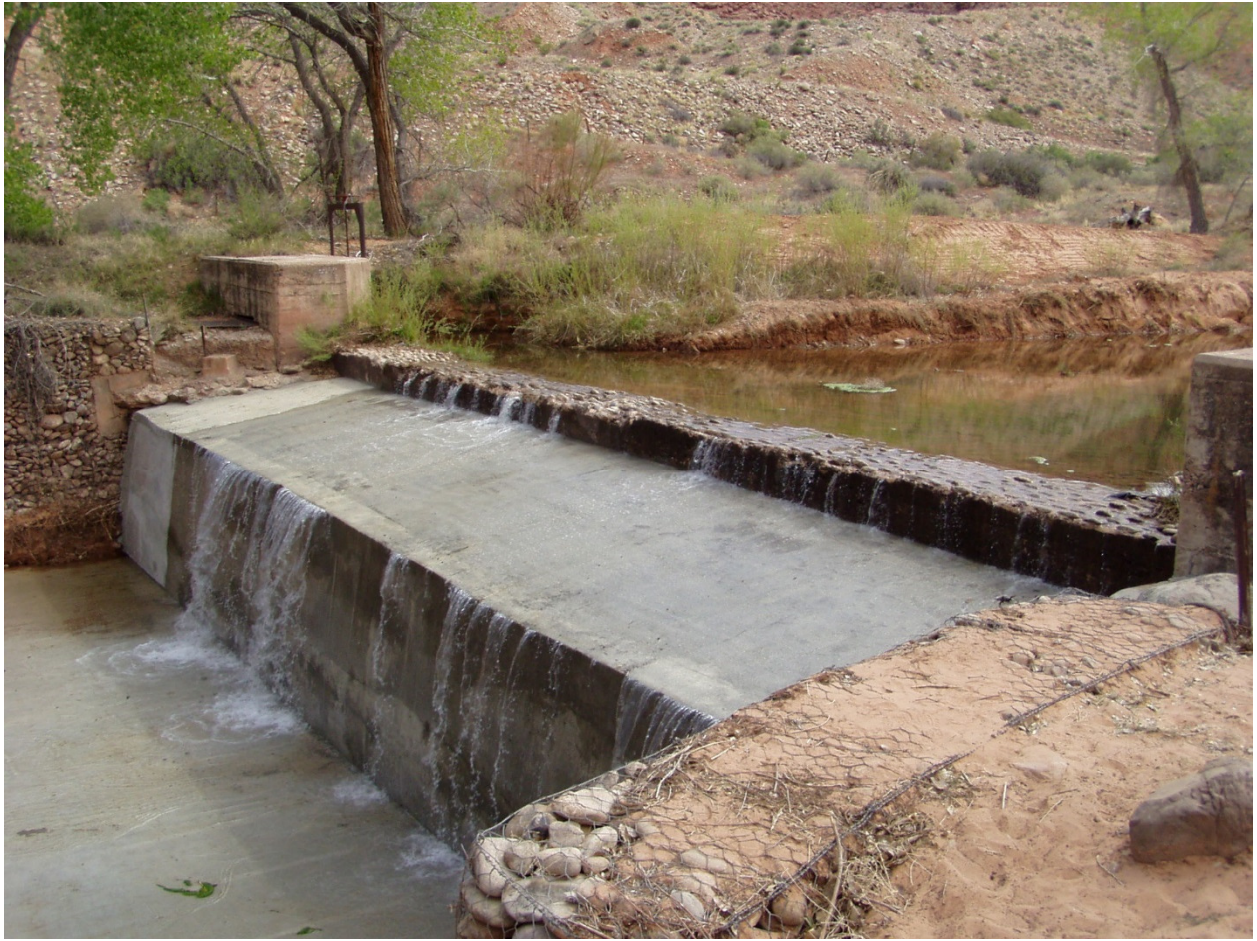
It looked pretty nice when it was all done.

The dam was placed back in operation and hopefully will last for many years to come. A special thanks to George Carter for all his work to get this project done.
